Title: **QUALITY AUDIT (Stage 1&2)  
INCLUDING ROAD SAFETY AUDIT  
For;  
Glenageary Gate LRD**

Client: **AECOM**

Date: **April 2023**

Report reference: **1130R02**

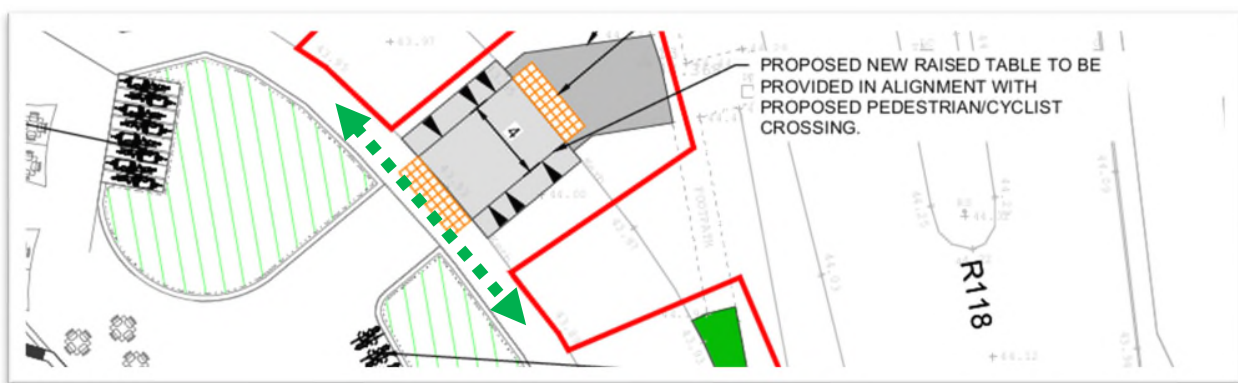
Drawing 60690914-ACM-00-00-DR-CE-10-0001 Rev 1, Glenageary Avenue ped/cyclist crossing.

It is proposed to provide a 4m wide pedestrian/cyclists crossing of Glenageary Avenue. The facility joins with the pedestrian footpath only on the western side of Glenageary Avenue. Pedestrians on this footpath may not anticipate cyclists sharing this space, especially if they are blind or partially sighted. This could lead to collisions between pedestrians and cyclists.

It is recommended that warning tactile paving (ladder) and signage be provided in advance of the shared use crossing.

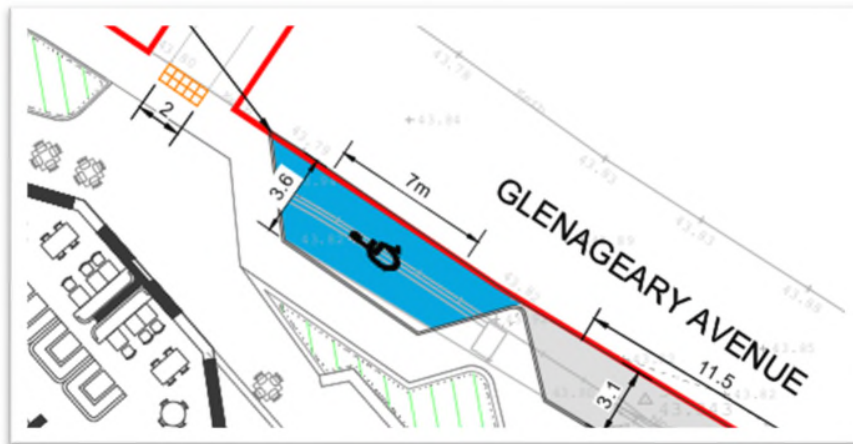
Drawing 60690914-ACM-00-00-DR-CE-10-0001 Rev 1, Glenageary Avenue, Disabled Parking Space.

It is proposed to provide a disabled parking space on Glenageary Avenue. It is unclear if a dropped kerb is to be provided to allow users of this space gain entry to the footpath without having to travel along the carriageway to the nearby uncontrolled crossing.

It is recommended that a dropped kerb be provided to facilitate access to the footpath within the parking space.

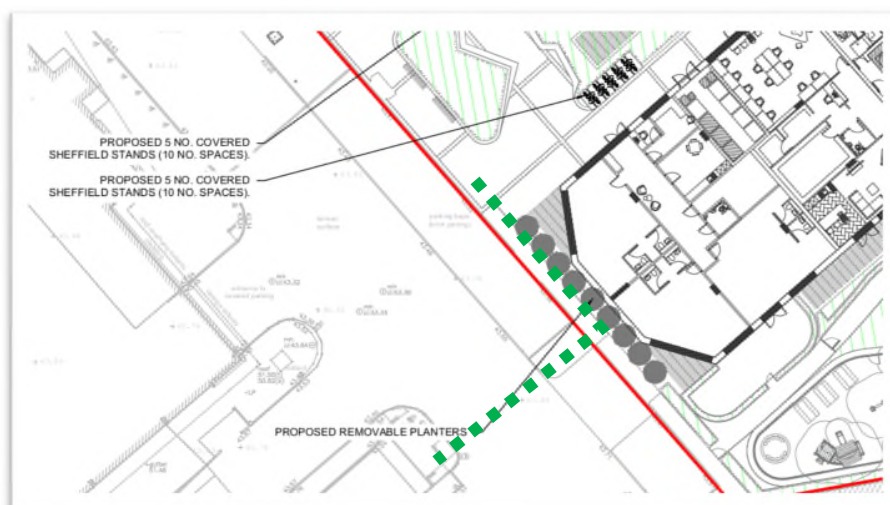
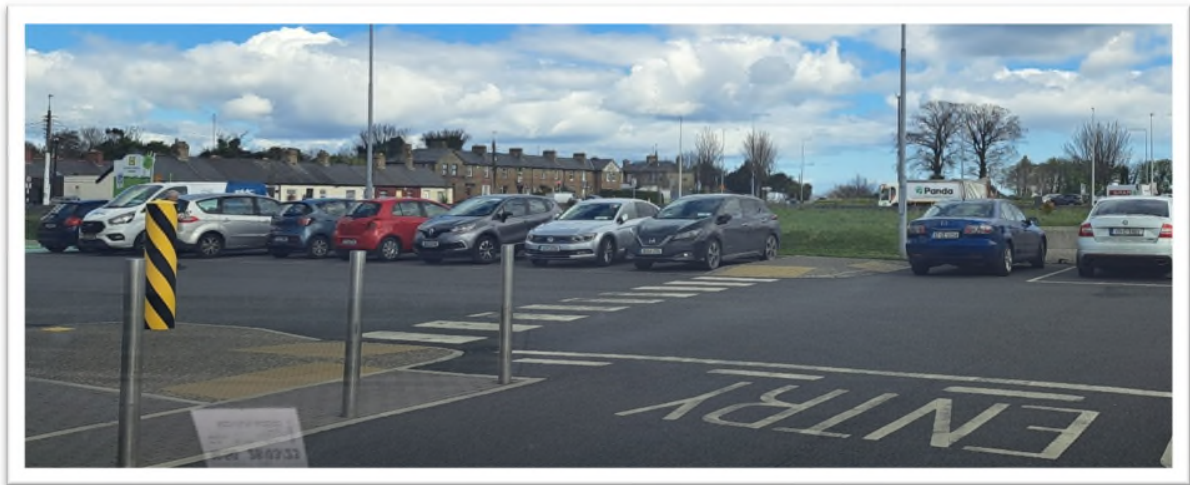
Drawing 60690914-ACM-00-00-DR-CE-10-0001 Rev 1, Lidl.

There will be a pedestrian desire line from the proposed Development to Lidl. It is unclear if this desire line is being accommodated with a path for pedestrians.

It is recommended that the desire line be accommodated with a clear route for pedestrians without steps or trip hazards.

3.1	Yes	Yes	N.A.	
3.2	Yes	Yes	N.A.	
3.3	Yes	Yes	There will be a 1.3m wide new footway provided at the rear of the existing car parking spaces, to facilitate the desire line from the existing zebra crossing to the proposed development.	Yes

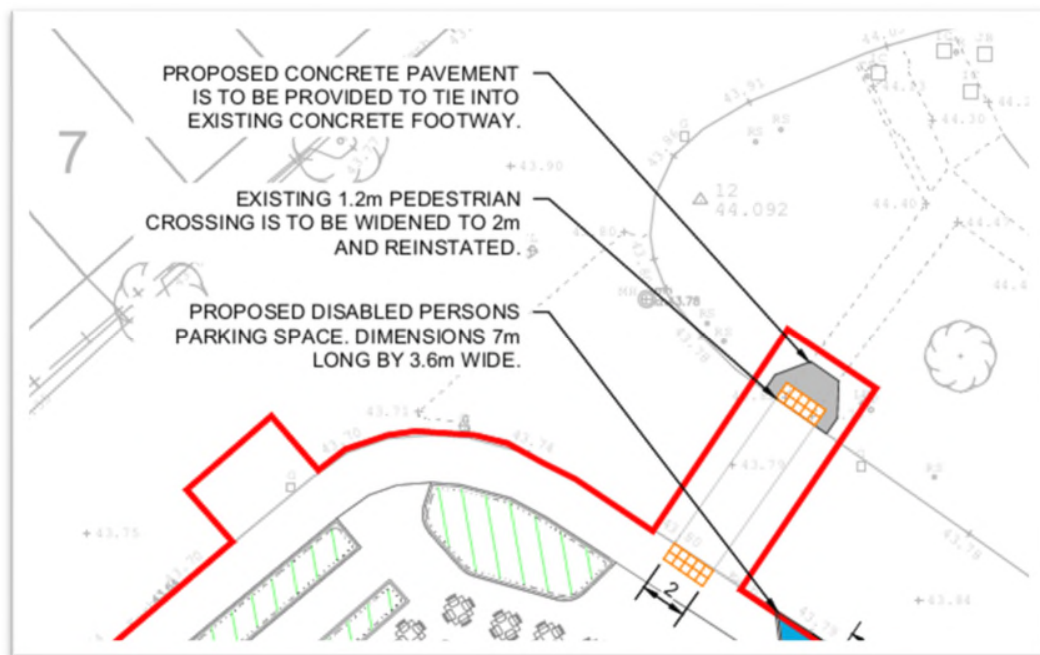
Drawing 60690914-ACM-00-00-DR-CE-10-0001 Rev 1, Glenageary Avenue, uncontrolled pedestrian crossing.

It is proposed to provide an uncontrolled pedestrian crossing on Glenageary Avenue. The start of the crossing on the island side towards Glenageary Roundabout forms an in-line crossing. The tactile paving of two slabs deep may not be enough to be adequately detected by some blind or partially sighted pedestrians which could result in those vulnerable road users stepping into the carriageway leading to possible collisions.

It is recommended that suitable depth tactile paving be provided at the in-line crossing.

3.4	Yes	Yes	As suggested, the tactile paving has been increased from 800mm (2 No. tactiles) deep to 1.2m (3 No. tactiles) deep.	Yes
3.5	Yes	Yes	New double yellow lines have been proposed on the nearside road carriageway from the proposed basement entrance to the existing An Post site entrance.	Yes

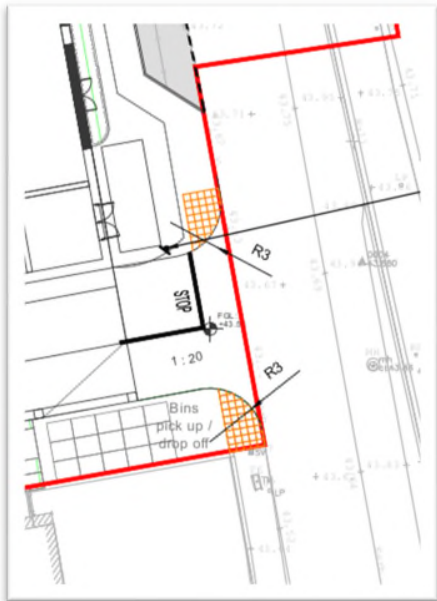
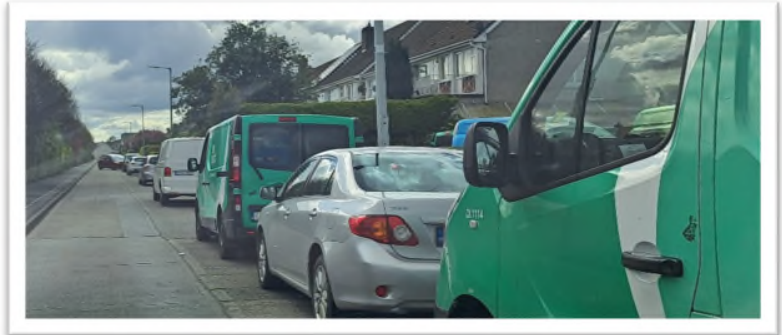
Drawing 60690914-ACM-00-00-DR-CE-10-0001 Rev 1, Glenageary Avenue, parking.

It was observed during the site visit that on-street parking occurs at the post office by both post office vans and members of the public. This could lead to blocking of visibility to the right for drivers exiting the basement car park leading to side-impact or rear-end collisions. Some parking was taking place where there are double yellow lines.

Provide suitable measures to prohibit parking within the visibility splay.

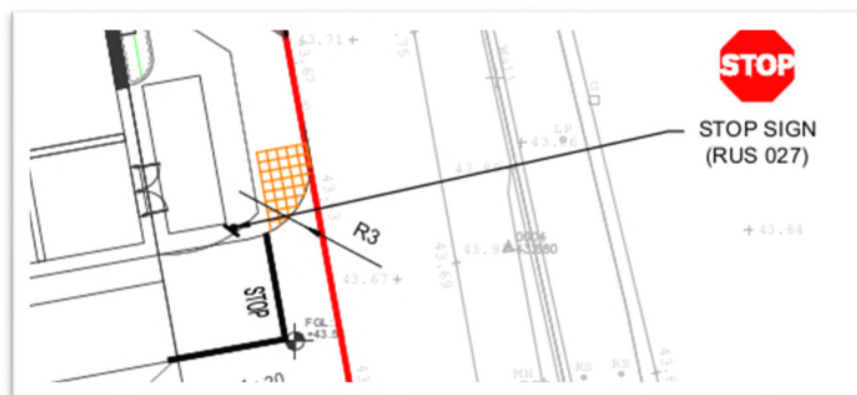
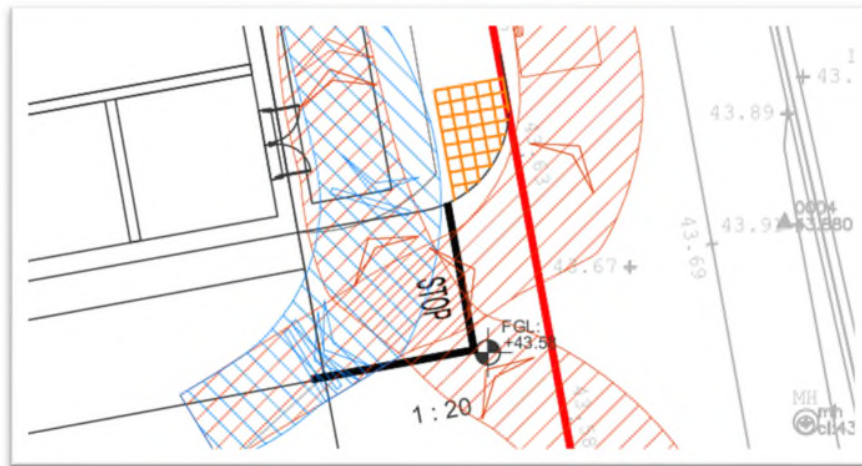
Drawing 60690914-ACM-00-00-DR-CE-10-0001 Rev 1, Basement access, Stop Sign.

The stop sign at the top of the basement ramp will be in the swept path for the ESB maintenance vehicle. This could lead to damage of the sign pole and drivers subsequently not being warned of the need to stop.

Relocate the stop sign to a suitable position where it will not be a hazard for pedestrians.

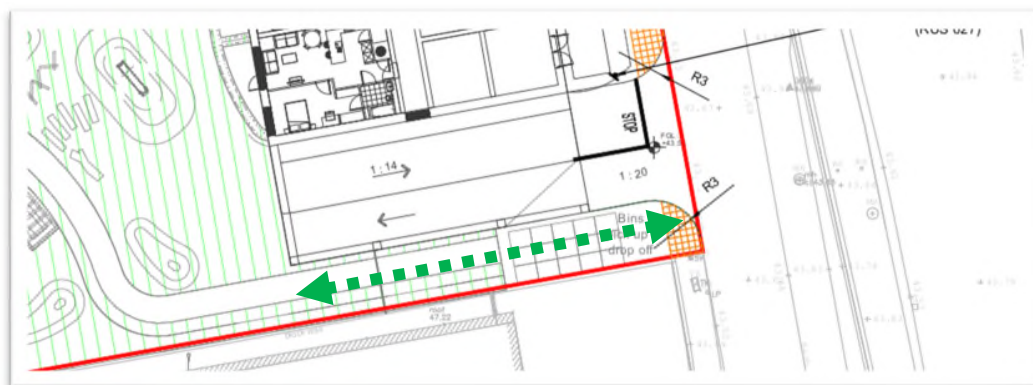
Drawing 60690914-ACM-00-00-DR-CE-10-0001 Rev 1, Bins Pick Up/Drop off.

The proposed bin pick up/drop off location appears to block access to the pedestrian route through the development from Glenageary Avenue.

Access should be allowed for pedestrians at all times.

3.6	Yes	Yes	N.A.	
3.7	No	Yes	The proposed rear garden will only be accessible by residents and not the public.  The proposed residential bin pick-up/drop-off point is only expected to be used as short-term bin storage during bin collection times. During all other times, the bins will be stored in the respective long term bin stores located within the basement.	Yes

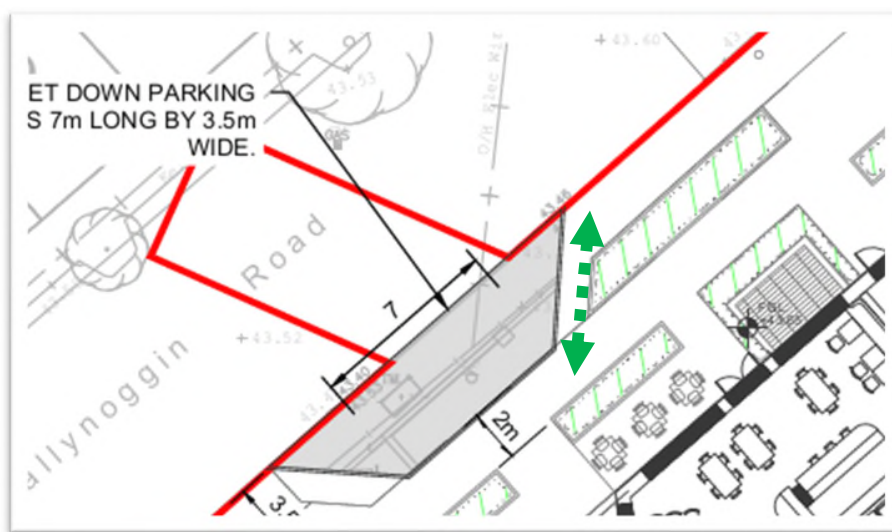
Drawing 60690914-ACM-00-00-DR-CE-10-0001 Rev 1, Set Down Parking Sallynoggin Road.

A set down parking space is proposed on Sallynoggin Road. The footpath at the rear of the parking space taper is relatively narrow and may not be sufficient for pedestrians to pass. Blind or partially sighted pedestrians may use the kerb edge to negotiate along Sallynoggin Road and not the area to the rear of the landscaped areas.

Ensure sufficient footpath space is provided.

3.8	Yes	Yes	A minimum of 2m clear footpath will be provided at all sides of the proposed set-down parking bay.	Yes

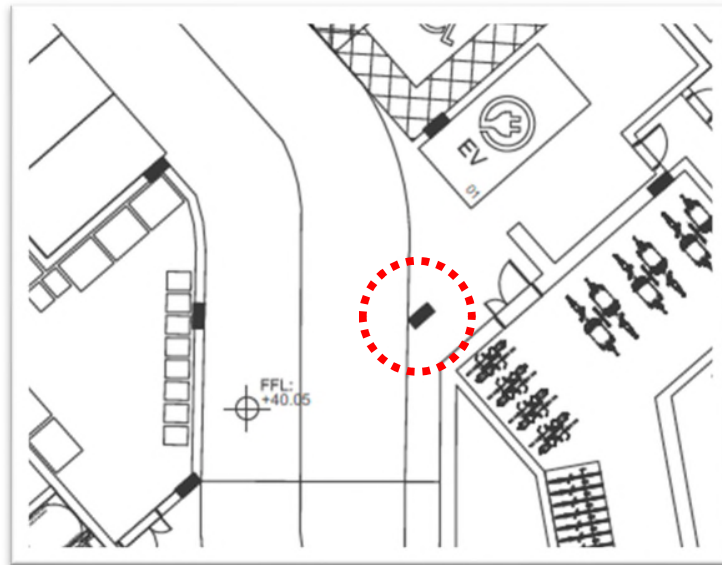
Drawing 60690914-ACM-00-00-DR-CE-10-0002 Rev 1, Basement.

There is a structural column at the edge of the exit lane that may be struck if not seen by drivers as it is isolated and may blend in with the walls.

It is recommended that the column be protected and/or highlighted or relocated.

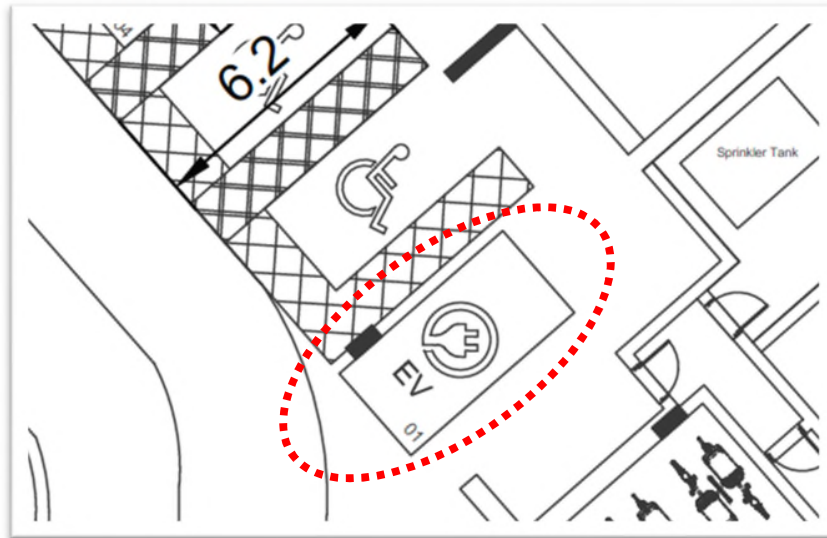
Drawing 60690914-ACM-00-00-DR-CE-10-0002 Rev 1, Basement.

It is unclear where the charging unit will be located for the single EV charging space adjacent to the sprinkler tank. Loose cables could lead to trips and falls if on the path of pedestrians.

It is recommended that the column be protected and/or highlighted or relocated.

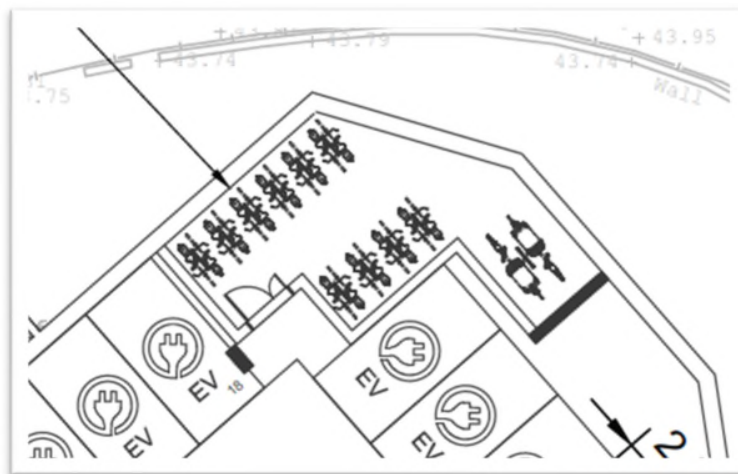
Drawing 60690914-ACM-00-00-DR-CE-10-0002 Rev 1, Basement.

It is unclear if the long stay cargo bikes can get out of the bike store if other spaces are occupied and the doors are opened.

Ensure sufficient space is provided for the cargo bikes to get into and out of the storage area.
